Service Center Inspection Form

2007 Acura TL PW040864

Score	16 / 25 (64%)	Flagged items	0	Actions	0
VEHICLE	2007 Acura TL PW040864				
MILEAGE	143516				
Prepared by	2007 Acura TL PW040864				
Vehicle Stock #	2007 Acura TL PW040864

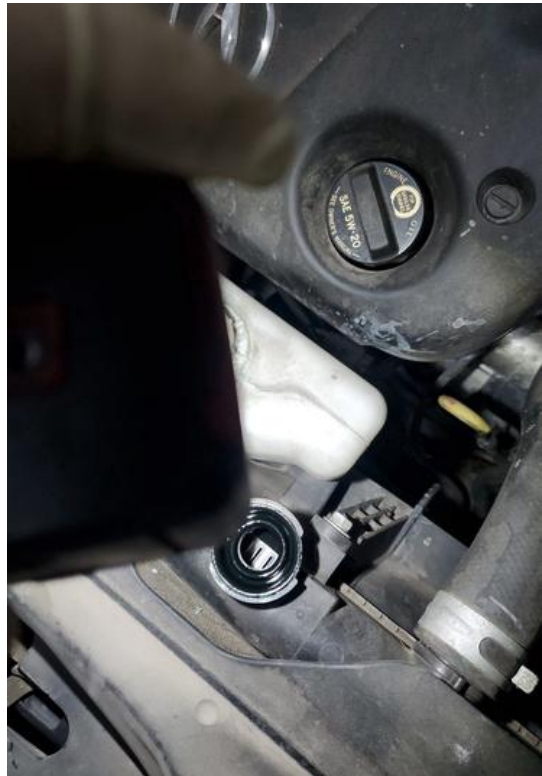
Photo 11

Low. topped off. See: Radiator

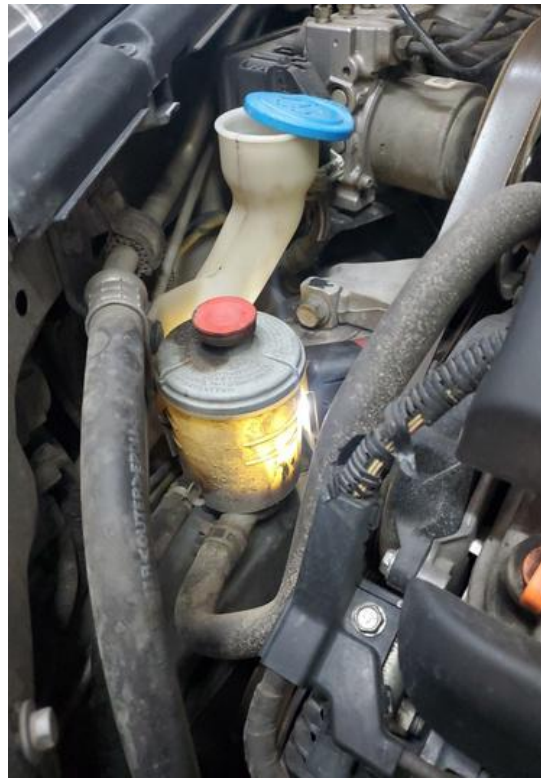
Photo 13

slightly dirty, no offensive odor.

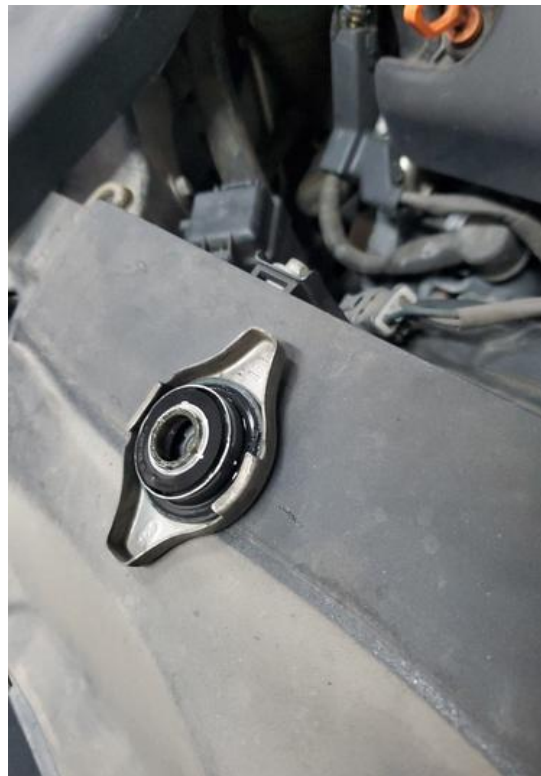
Photo 15

Good

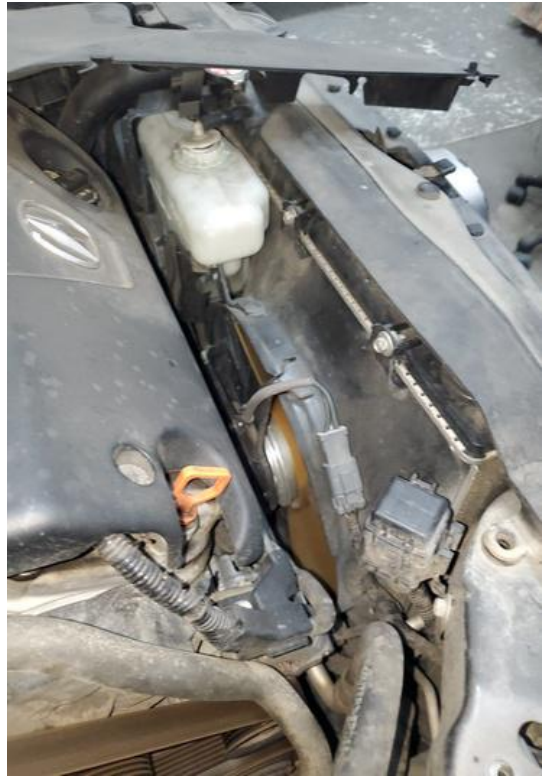
Photo 17

coolant staining found around coolant bottle and surrounding areas. cap to coolant bottle is split. removed

radiator cap to find a portion of it missing, causing there to be no seal on cooling system, when car gets warm, it pushes coolant into overflow bottle which then pushes excess coolant out of the bottle onto surrounding area.

rec replacement of radiator cap and coolant overflow bottle cap.

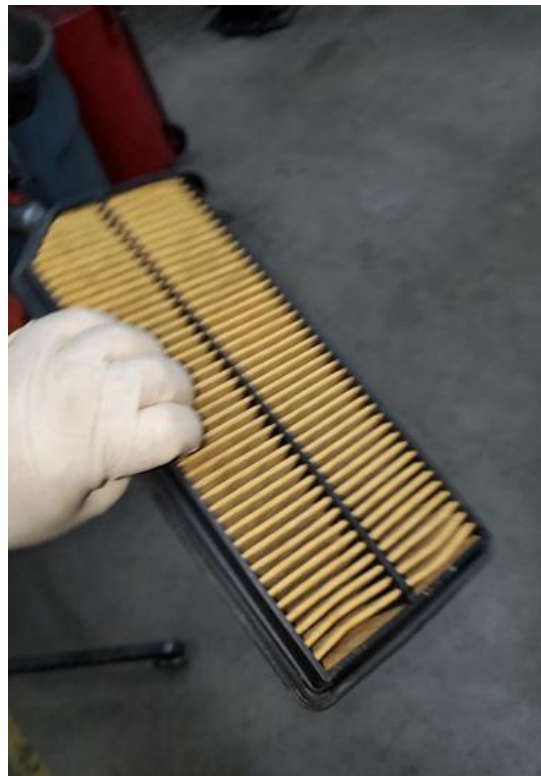
Photo 35

very dirty. rec replacement

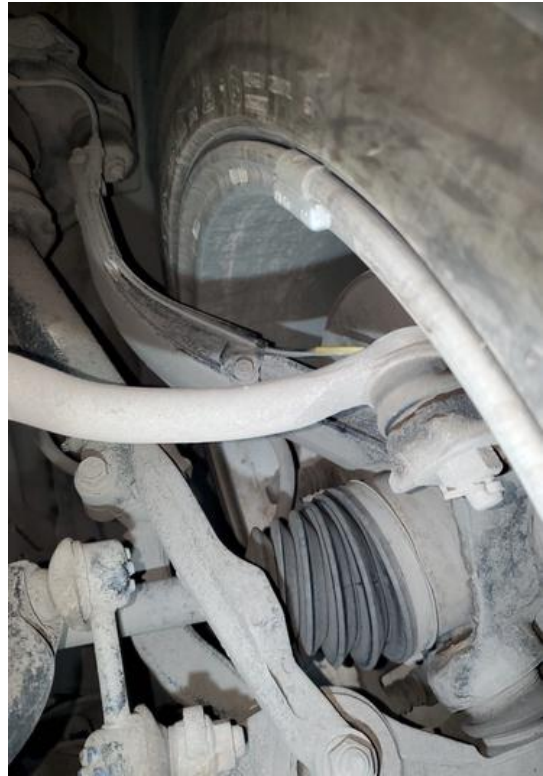
Photo 37

LF Lower control arm forward bushing is broken/torn. rec replacement of LF Lower control arm

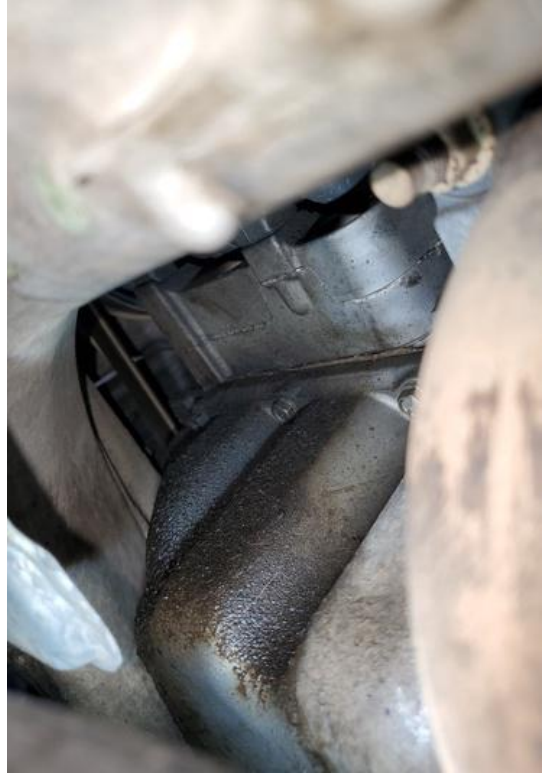
Photo 49

there are signs that vehicle has oil pump seal leak, and oil pan leak. Leaks are not actively dripping at this time.

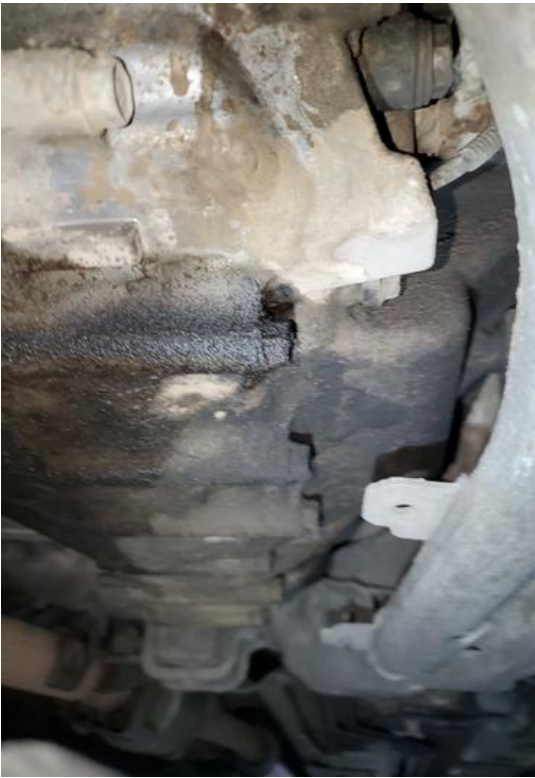
Photo 54

there are signs of transmission leak from the case seams. not actively dripping at this time.
